Atlantic Croaker at the Coastal Virginia Offshore Wind Farm

SAFMC Habitat and Ecosystem Advisory Panel
Summer 2025

Coastal Virginia Offshore Windfarm (CVOW)

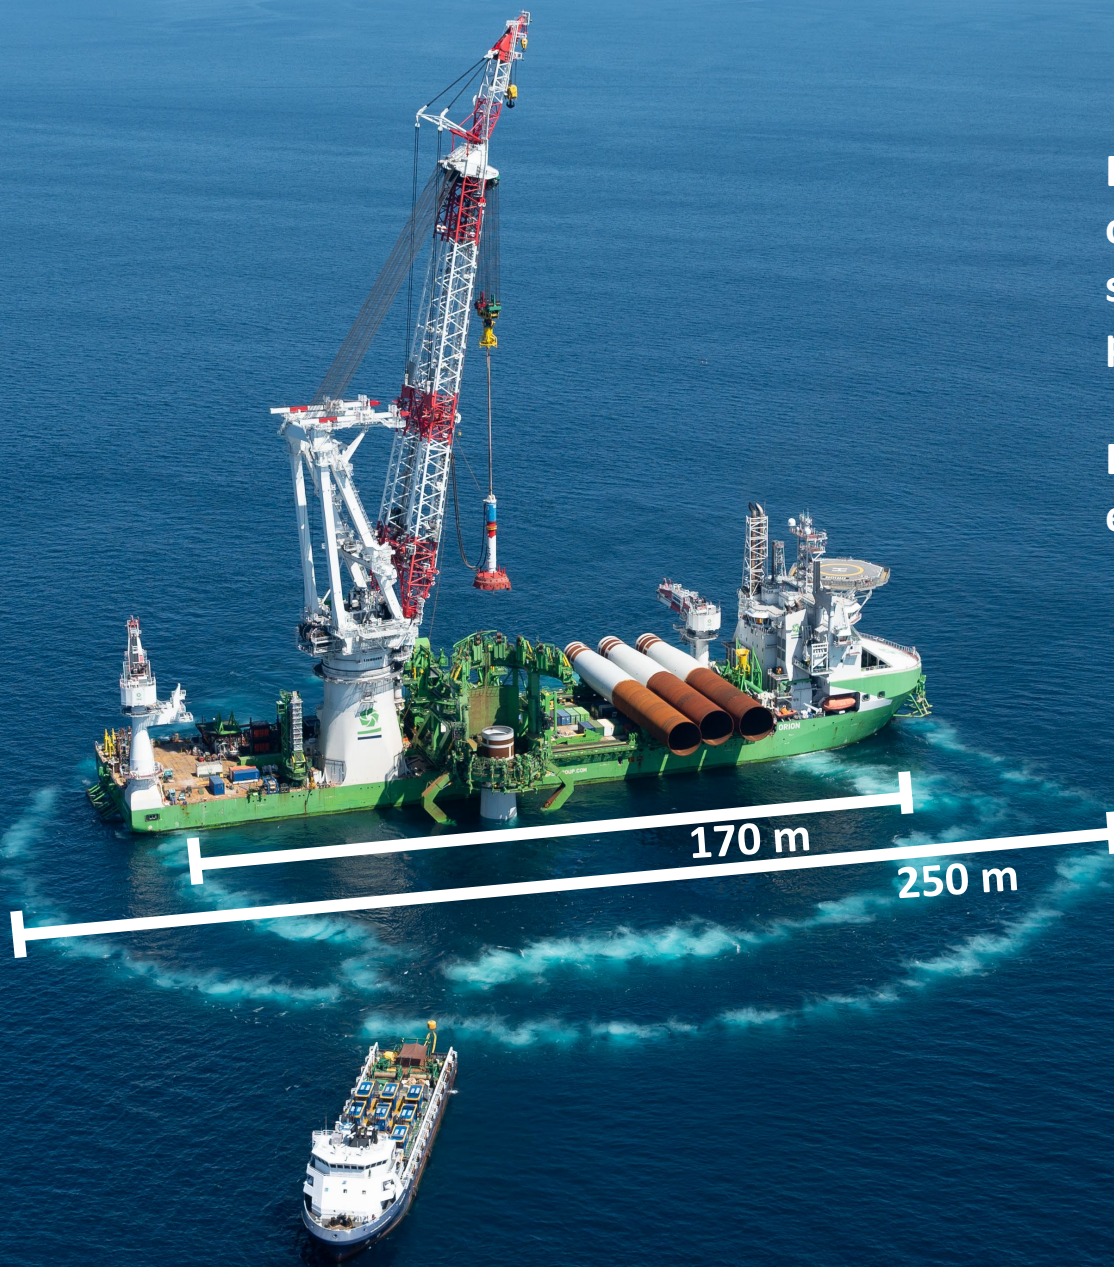
Bubble curtains are used during installation of monopile foundations to attenuate sound, thereby reducing noise impacts for protected species & fish

Double bubble curtains can reduce sound energy level by 90 %
