NOAA Technical Memorandum NMFS-SER-5

POTENTIAL IMPACTS OF ARTIFICIAL REEF DEVELOPMENT ON SEA TURTLE  
CONSERVATION IN FLORIDA

January 2017

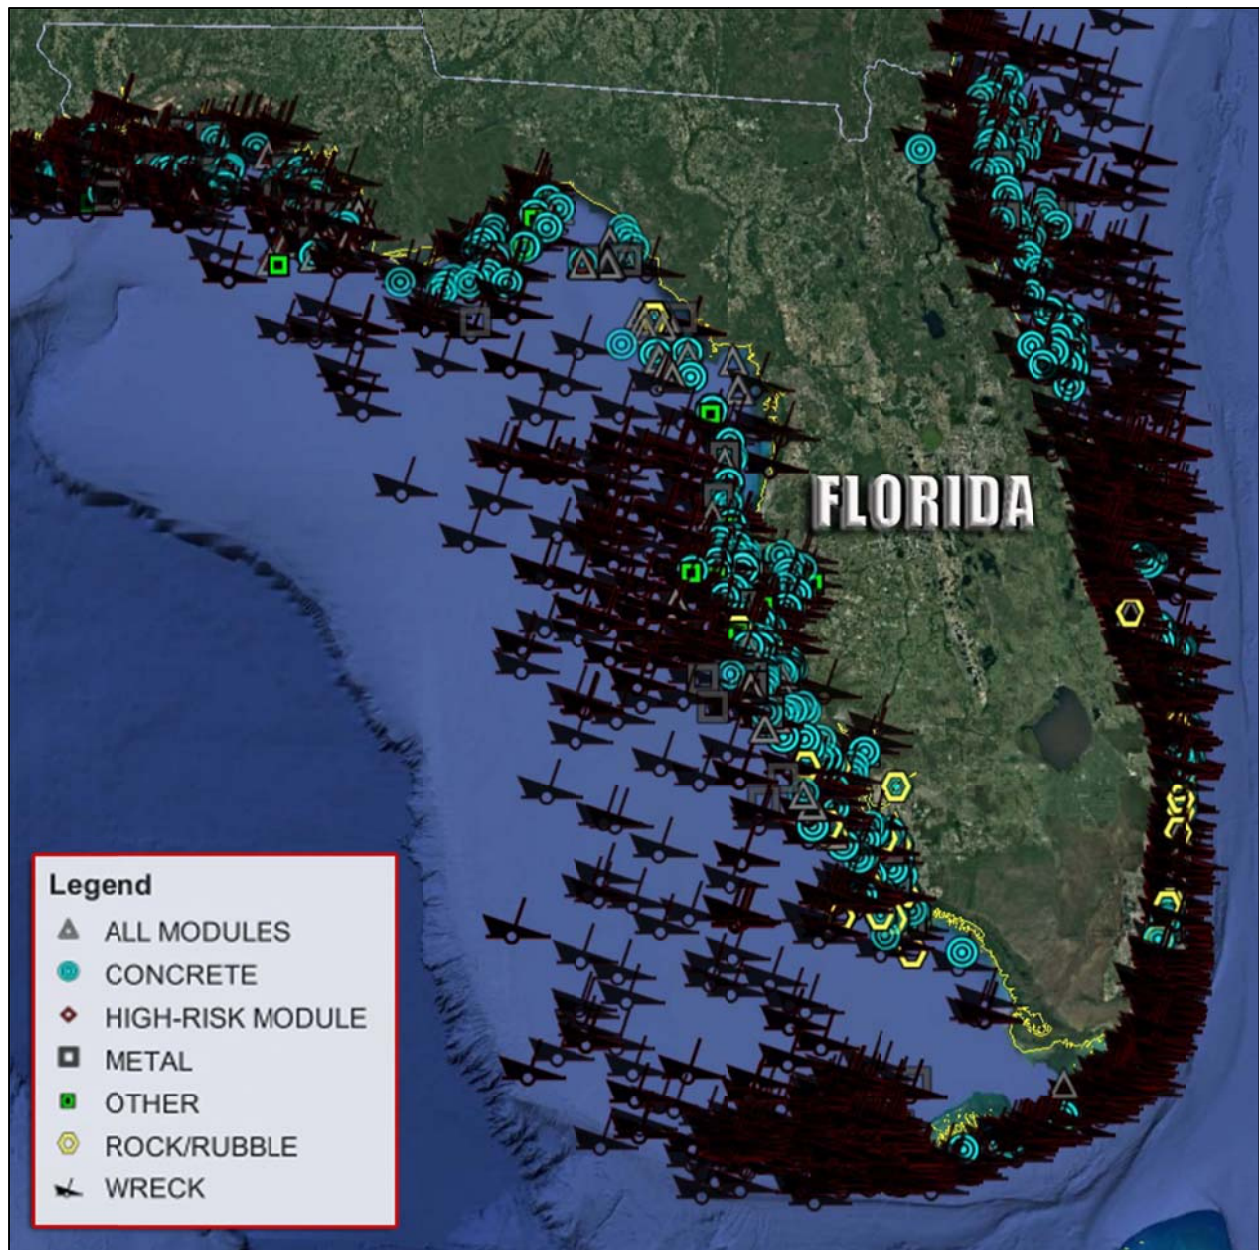
**Figure 1.** Map illustrating abundance of artificial reef material and shipwrecks off Florida, with over 7,000 sites in the author's database.

As of October 2015, the various Florida county artificial reef programs have deployed more than 627,497 tons of concrete material and 258,817 tons of limestone rock and rubble, as well as over 18,769 prefabricated artificial reef modules and 513 vessels in coastal waters (FWC database 2015). In addition, there have been several hundred small, “private reefs” deployed off Escambia, Okaloosa, and Bay Counties in the Florida Panhandle, as well as countless more unpermitted, covert deployments of various materials elsewhere off Florida, not to mention thousands of Florida shipwreck events that have transpired throughout history (Figure 1). In some permitted artificial reef areas, the amount of material can be quite dense (Figure 2).

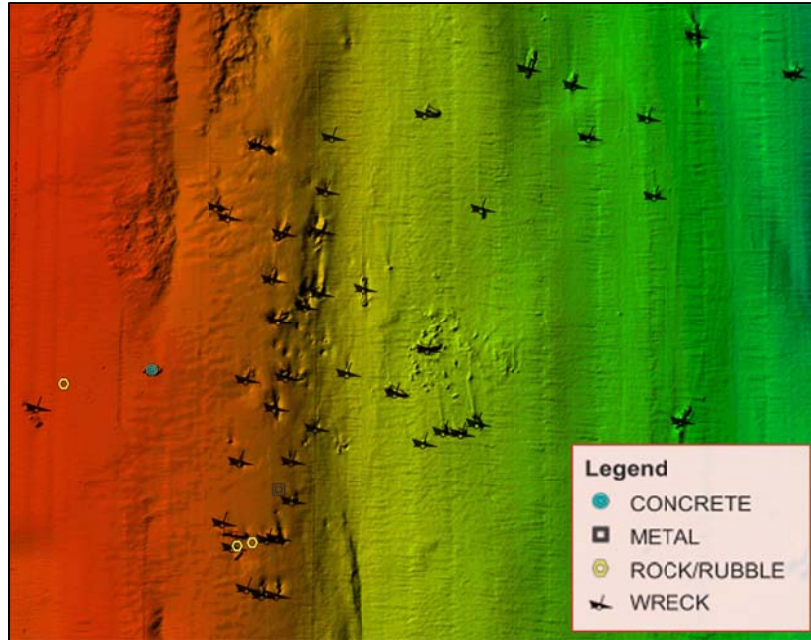
**Figure 2.** Artificial reef site off Miami-Dade County, illustrating the density of material in one discrete (~1.6 x 1.1 kilometer) area.

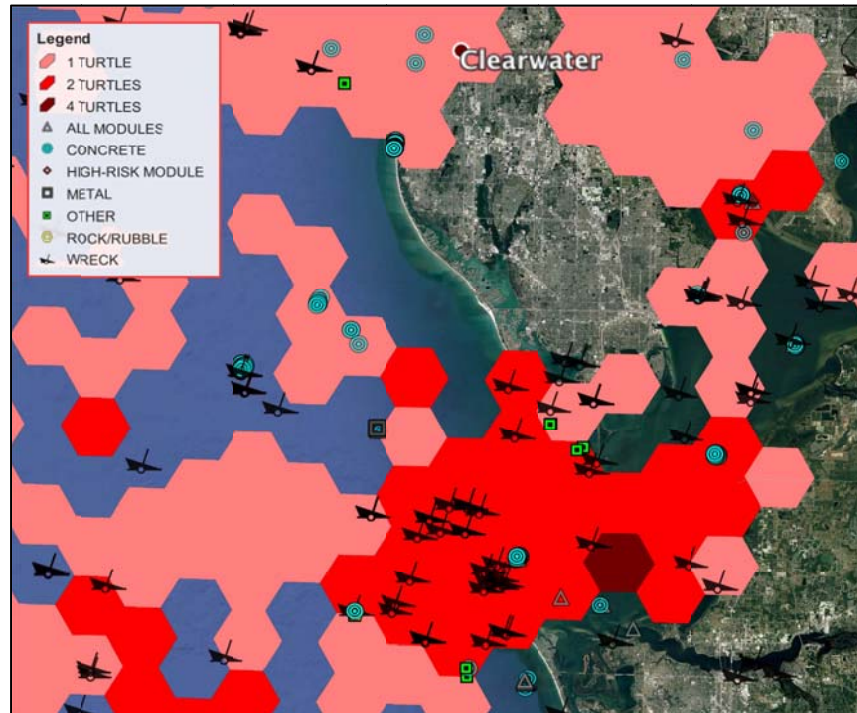
**Figure 4.** Artificial reefs and shipwrecks off Tampa Bay, in relation to overlapping residence areas of individual adult female loggerhead sea turtles represented as counts of unique individuals within five-kilometer hexagonal cells (from Hardy et al. 2014).

Hardy et al. (2014) examined satellite-tracking datasets from 125 tagged adult female loggerhead sea turtles to determine residency areas on the West Florida Shelf. That study ultimately pooled the data of 81 individual turtles and summarized residence area use within five-kilometer diameter hexagonal grid cells to determine the number of individuals present within each cell. In many areas of the West Florida Shelf, these cells overlap with permitted artificial reefs and shipwreck sites (Figure 4). It is unclear how often sea turtles utilize artificial reef material off Florida, but in some areas their utilization could be quite significant. As a result, those sea turtles may be exposed to potential threats associated with artificial reefs (e.g., entanglement) discussed further in this study.

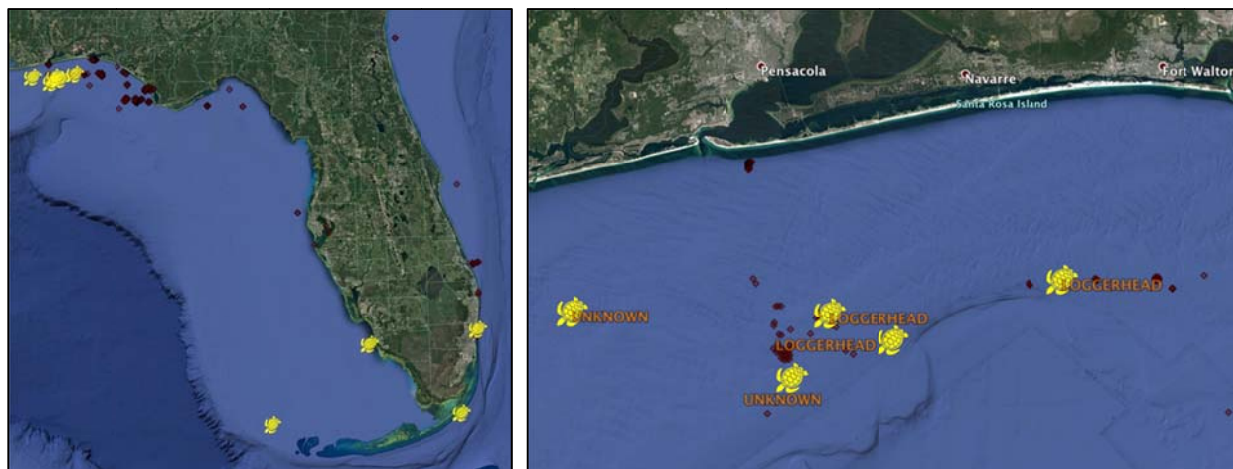
**Figure 5.** Map at left illustrating locations of documented sea turtle mortalities due to confirmed or suspected entrapment in artificial reef material or shipwrecks; at right, five mortalities associated with artificial reef modules off Escambia and Okaloosa Counties. The red symbols are the locations of artificial reef modules that present a high risk of sea turtle entrapment.

As previously mentioned, sea turtles may spend a significant amount of time underwater resting and are known to utilize artificial reefs and shipwrecks in lieu of natural habitat as sheltering habitat. As air-breathing animals, sea turtles obviously are vulnerable to drowning if they are unable to return to the surface to breathe. Bycatch and forced submergence has been documented as a significant source of mortality in several fisheries (Poiner and Harris 1996, L.L. Lum 2006, Finkbeiner et al. 2011), but there have also been numerous documented incidents of sea turtles becoming trapped inside artificial reef material and perishing (Table 1, Figure 5).

Entrapment in artificial reef modules, incidents which consist of over half the documented instances in Table 1, appear to be restricted to materials that possess an open bottom and closed top (see Figure 6 for some examples). Artificial reef modules have been constructed in this fashion to allow efficient stacking on a barge's deck for transport to an offshore artificial reef site. This, however, also allows a sea turtle to potentially gain access to the module's interior if sand around the bottom edge of the module is washed out or excavated by a turtle or other marine species (Figure 7). It is assumed that light entering the module from above, added with the turtle's inherent desire to surface to breathe, potentially prevent the turtle from exiting the module before drowning. Other circumstances may prevent proper deployment of a particular module, which could exacerbate (e.g., a module coming to rest on top of other artificial reef material that produces a gap under the module's edge) or eliminate (e.g., a module coming to rest on its side) these entrapment issues. In addition, degradation of artificial reef material over time may reduce the entrapment threat.

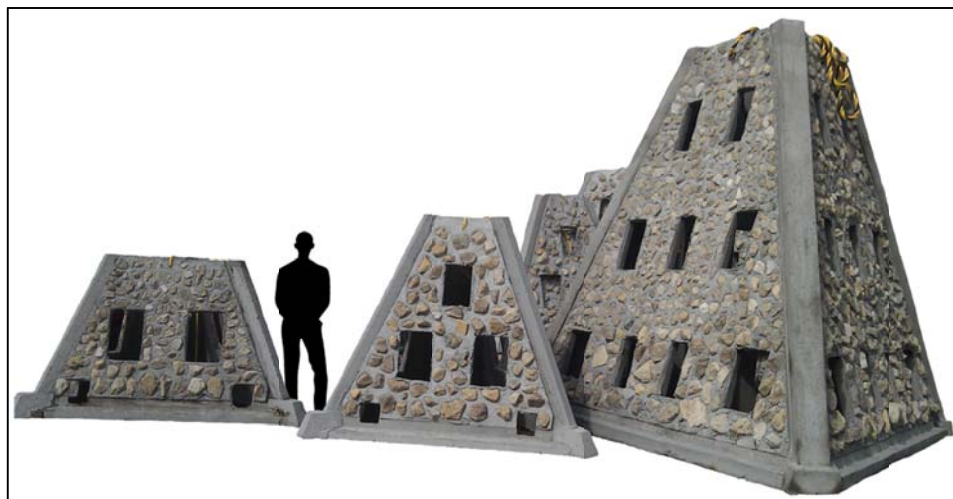
**Figure 6.** Various artificial reef modules: at left, a modified fish haven with open top, while center and right are restricted top pyramid modules.

Prefabricated modules such as open-bottom, closed-top pyramids can allow sea turtles to gain access to the interior and potentially drown. These modules should not be utilized due to this documented risk. Instead, solid or closed-bottom modules should be the standard parameters for prefabricated modules. Modified designs, such as open-top fish haven modules could also be considered as low risk, if the opening in the top is sufficient to allow an adult sea turtle to escape. For triangular modules, that opening should be a minimum of 4 feet on each side. Due to the lack of documented or anticipated interactions between artificial reef modules and leatherback sea turtles, this study employs a conservative opening size based on the maximum observed carapace width for loggerhead sea turtles (K. Hart, personal communication, May 9, 2016). It is also important that these modified modules not retain any lifting point lines that may restrict the module’s opening at the top. Materials such as rock, rubble, and some secondary-use concrete materials also could be considered for preferential use due to an anticipated absence of entrapment hazards.

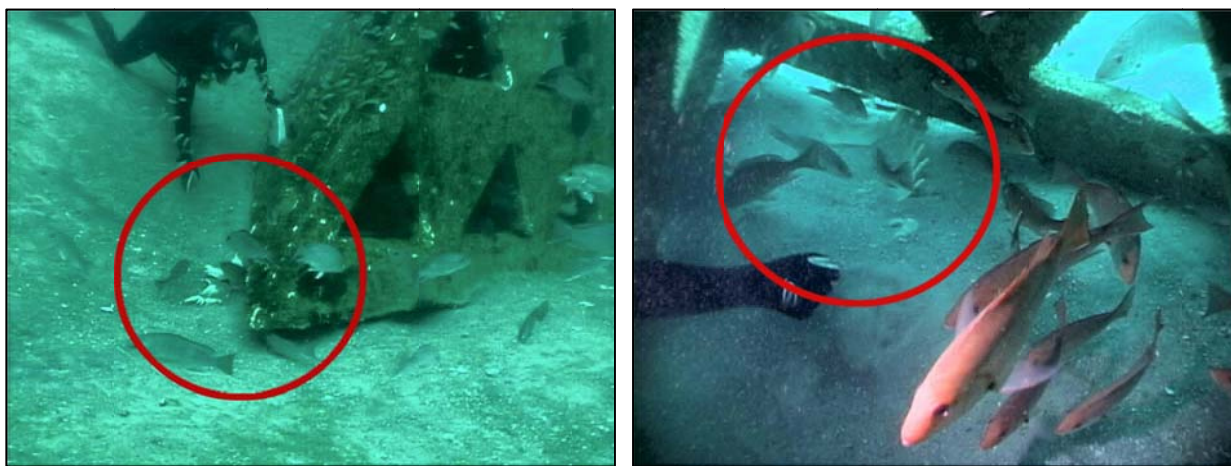
**Figure 7.** Images of sea turtle skeletal remains under a fish haven module off Escambia County (Images courtesy of FWC Artificial Reef Program).

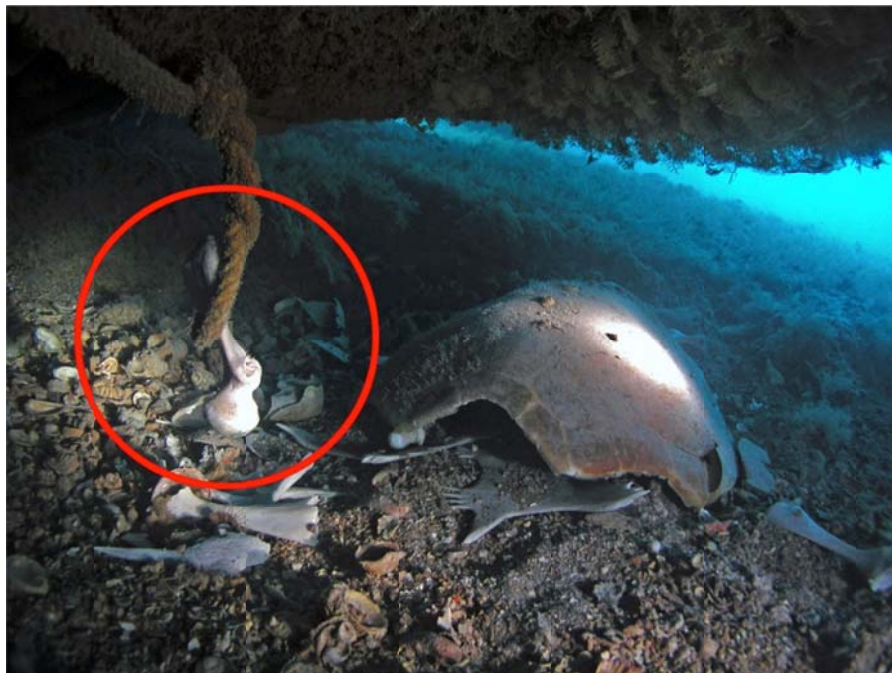
**Figure 8.** Skeletal remains of a loggerhead sea turtle; note humerus bone still hanging in a loop of lost anchor line.

While it may be easy to determine entanglement in a freshly dead or decomposing sea turtle, it is less so when the turtle is fully skeletal. Monofilament or other line may no longer be visibly entangling the remains, predators may scatter bones to further confound the scene, or the bones become covered by sediments over time. In some instances, however, evidence lingers. In 2007, the author observed the fully-skeletal remains of a large loggerhead sea turtle underneath the wreck of the *Baja California* southwest of Naples at a depth of 35 m, with the humerus bone still suspended directly above in a loop of anchor line (Figure 8). Dead sea turtles observed on artificial reefs and shipwrecks, particularly when skeletal, may certainly have perished due to causes other than entanglement (or entrapment) when definitive evidence is lacking. For example, in 2013 the Sea Turtle Stranding and Salvage Network received information of a decomposing hawksbill sea turtle on the wreck of the *Mercedes*, an artificial reef deployed in 1985 off Broward County. Given that one-third of the rear shell was missing, it was concluded the mortality was due to shark predation. It is possible the turtle was preyed upon at the artificial reef or perhaps some distance away, with currents subsequently transporting the carcass into the wreckage. Nevertheless, entanglement can be suspected in many cases, even in the absence of more definitive evidence; this is typically the situation when skeletal remains are found in close proximity to abundant monofilament or anchor lines on artificial reef or shipwreck material, and other evidence indicating another source of mortality is lacking.

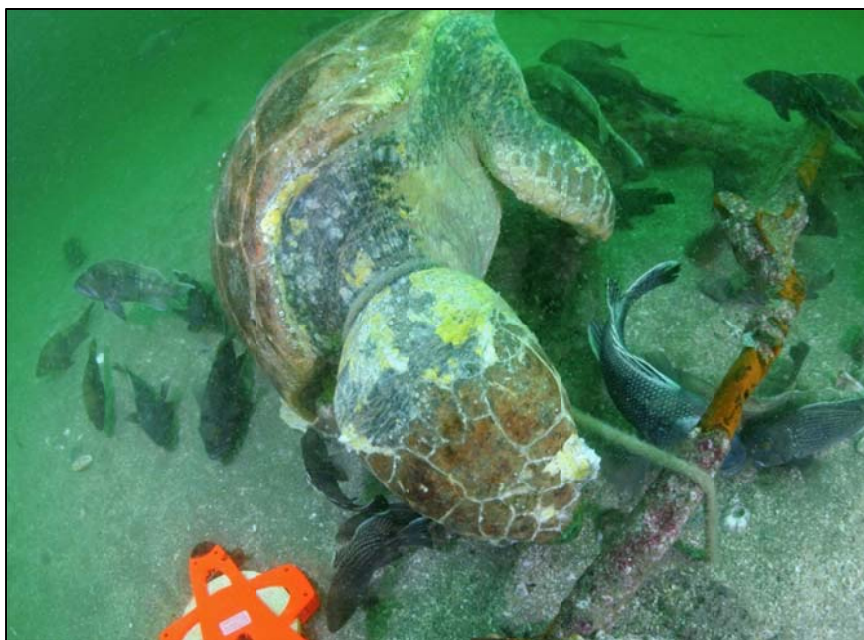
**Figure 9.** Loggerhead sea turtle entangled in an anchor line on World War II aircraft debris. Two weeks later there was no trace of the carcass or skeletal remains.

The decompositional process may also hinder identification of sea turtles that drowned due to entanglement in other ways. Specifically, as decompositional gasses build, a sea turtle carcass may become buoyant. That buoyancy, coupled with current or surge, could result in a carcass “disappearing” from the scene. This scenario was documented following the observation of an entangled loggerhead sea turtle on the wreck of a World War II aircraft off Volusia County in 2010. While the site consisted of only a small, low relief debris field less than 15 m in length, a single fouled anchor line successfully entangled a large loggerhead turtle. When originally observed, the turtle was freshly dead; initially, it was thought the turtle was merely resting on the bottom. Upon closer examination, however, the mechanism of entanglement became obvious (Figure 9). While firmly anchored to the bottom when initially observed, upon revisiting the site two weeks later there was no trace of the turtle to be found. It is unclear if its disappearance was due to decompositional processes, predation, or some other scenario. Regardless, it demonstrated the ephemeral nature of some of these entanglement incidents and the short window of opportunity one has to properly document evidence on a fresh turtle carcass that is immersed in the marine environment.

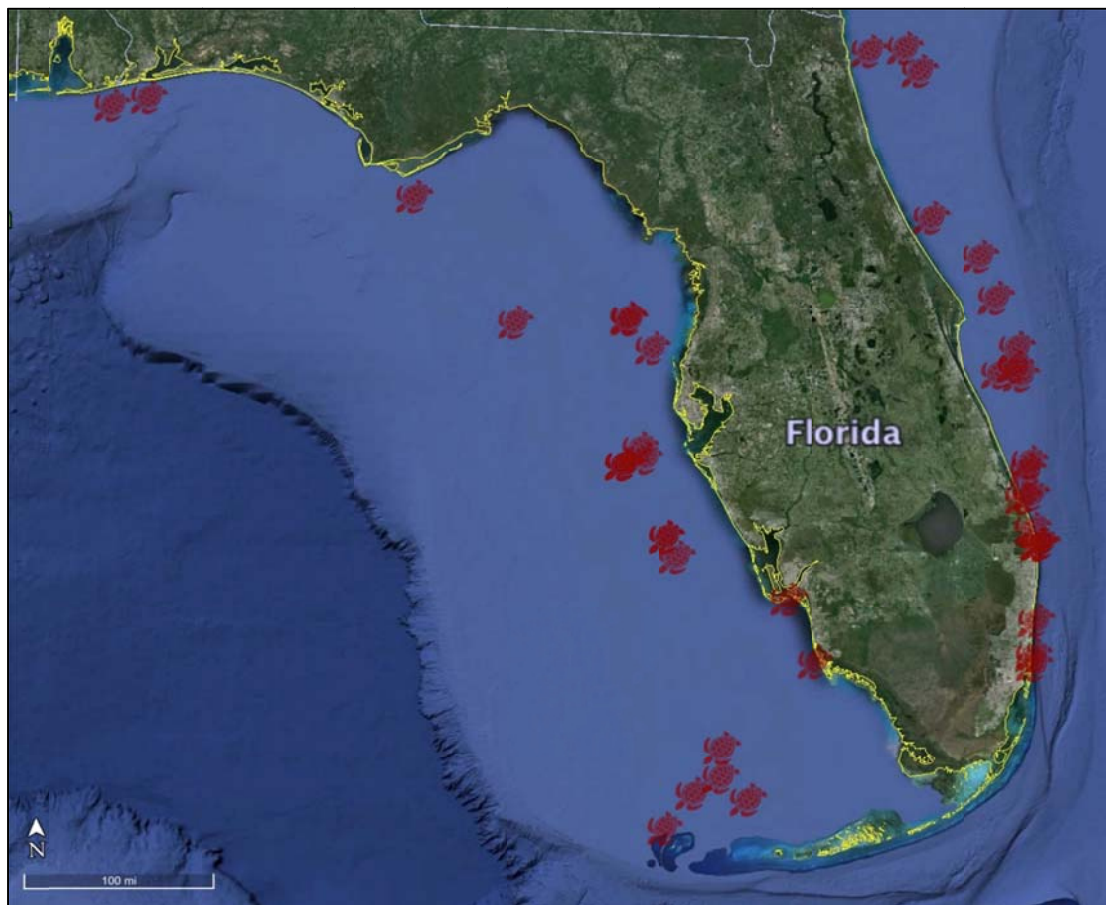
**Figure 10.** Map illustrating locations of over 40 documented sea turtle mortalities due to confirmed or suspected entanglement in artificial reefs or shipwrecks.

Franklin, Hernando, Hillsborough, Lee, Manatee, Martin, Monroe, Miami-Dade, Palm Beach, Pasco, Sarasota, St. Lucie, and Volusia; Figure 10). Of the reported sources of entanglement, 14 were cited as monofilament line, 8 were due to ropes or anchor line, 4 were associated with trawl nets, and 3 listed cast or gill nets. Fifteen entries listed the entanglement source as unspecified or unknown; the majority of these were associated with skeletal sea turtle remains in proximity to material that had entanglement hazards present. Based on identified sea turtle species, loggerhead was the dominant species comprising 82% of the records, followed by green and hawksbill at 6% each. The oldest site was attributed to a vessel lost in 1872 (observation made in 2000), while the newest site was a vessel intentionally deployed as an artificial reef in 2007 (observation made in 2014). Fifteen of the sites were associated with permitted artificial reefs (14 in Florida and 1 in Alabama). Nine sites reported multiple turtle mortalities, either from the same observation or over time. Two of the documented entanglement interactions occurred with live turtles; had divers not intervened and removed the entanglement, the turtles would likely have drowned.

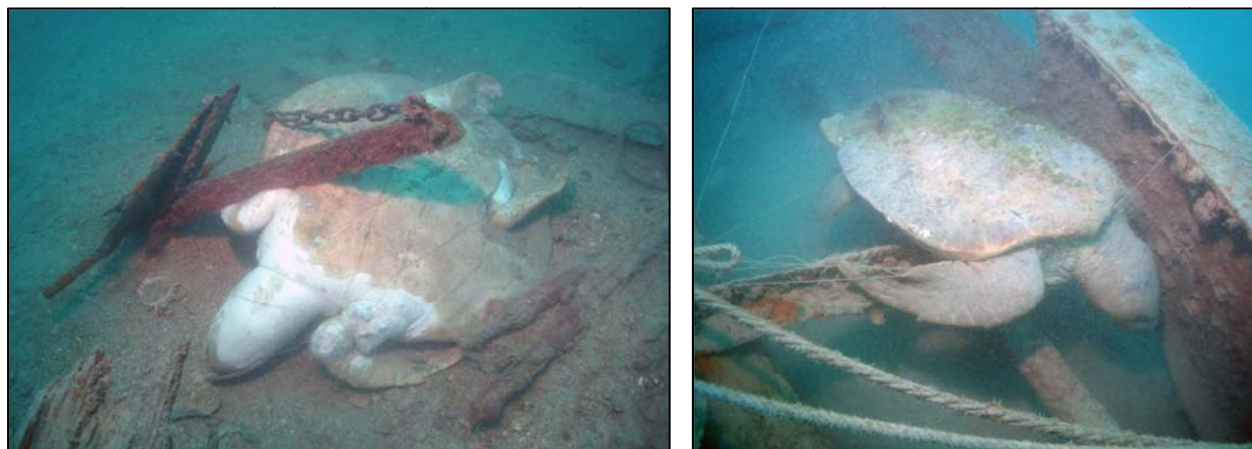
**Figure 11.** Images of two entangled sea turtles observed on the same day in 2006 on the “Pillsbury Wreck” off Manatee County.
